Milne Bay Aquatic Centre  
Toowoomba, Qld  
Olympic Pool Remediation

### Olympic Pool Remediation

Site: Milne Bay Aquatic Centre – Toowoomba, Qld

Client: Toowoomba Regional Council

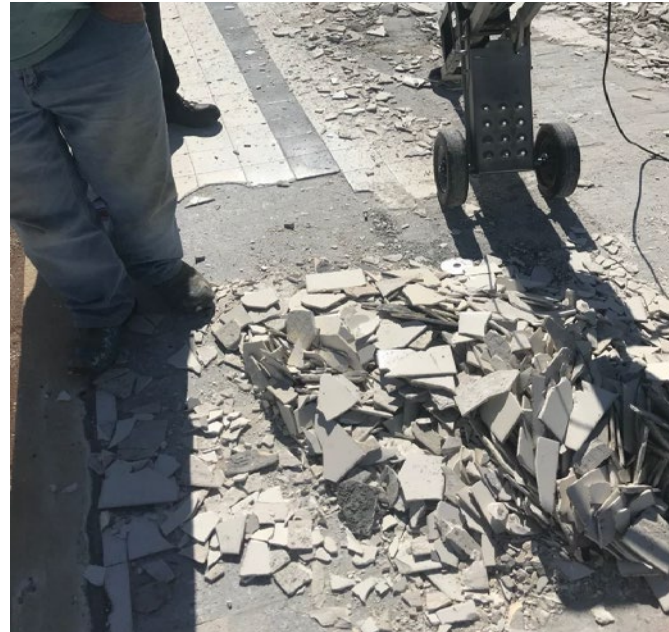
Removal of tiles and fiberglass lining.

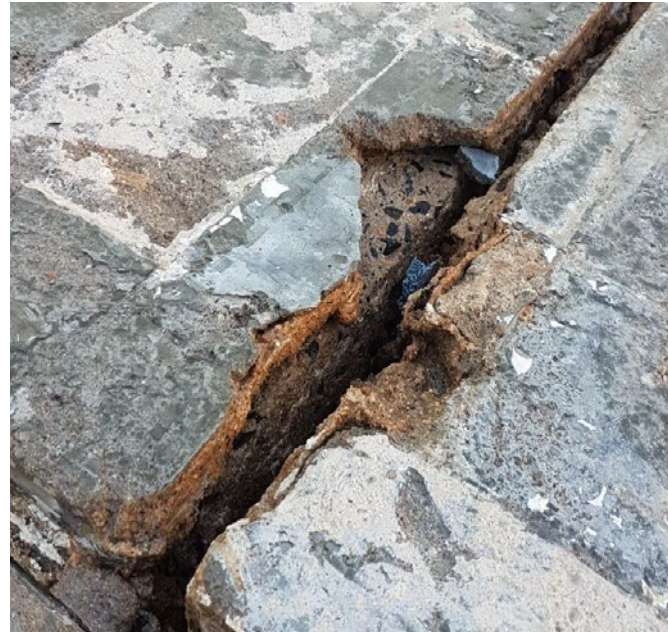
Investigate and report on condition of construction and expansion joints. Propose solution to remediate.

- Upon removal of the fibreglass and tiles, it became evident the joints were quite damaged and several areas required Re-profiling before they could be Re-sealed. Re-profiling basically meant re-construction of the joint with epoxy/sand mix and then re-grinding the joint gap to the required depth and width. Expansion joints required a complete bandage detail to provide optimum protection. Remediated as per scope.

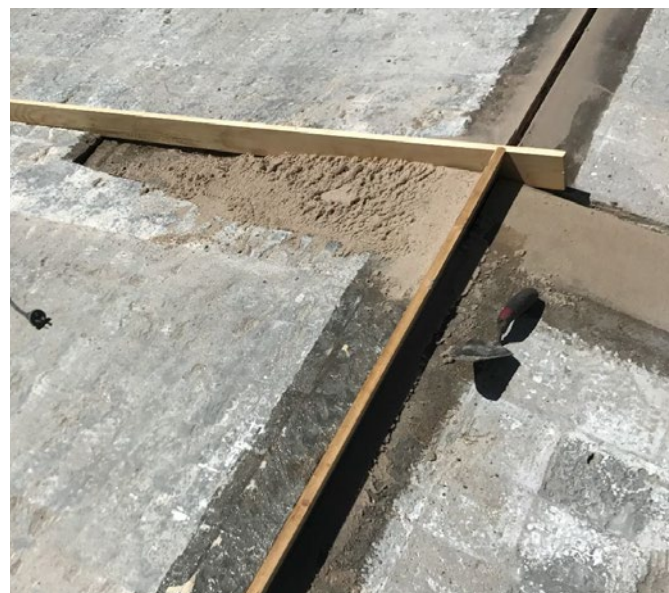
Epoxy resin system Repair to Joint Junction.

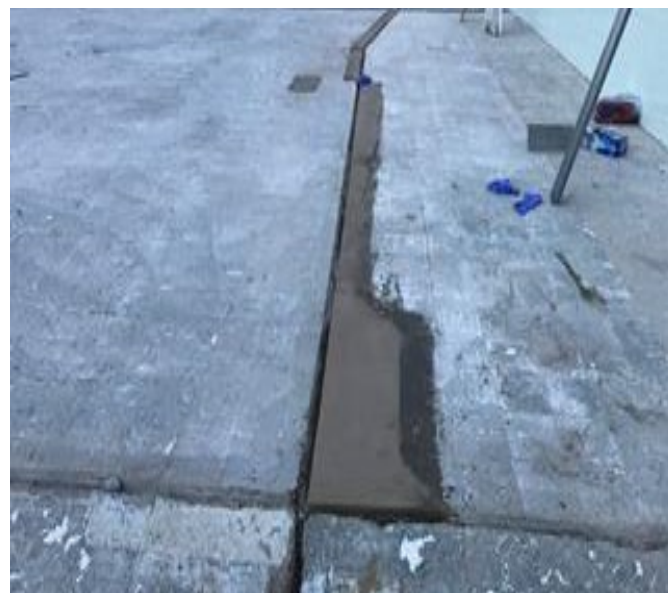
Epoxy Joint Repair - Troweled off to Match Original Substrate and Joint Profile.

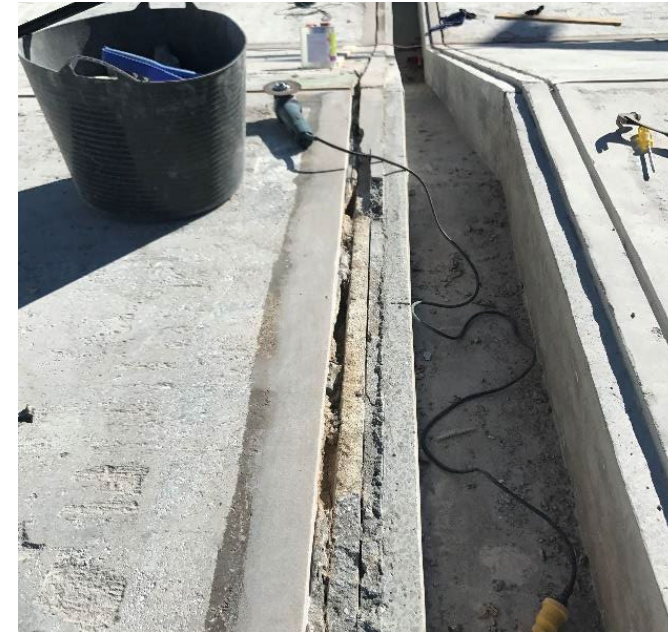
Investigate and report on condition of centre feed line channel. Propose solution to remediate.

- Upon removal of the Stainless Steel cover plates, it became evident the joints were quite damaged and several areas required Re-profiling before they could be Re-sealed. Re-profiling basically meant re-construction of the joint with epoxy resin/sand mix and then re-grinding the joint gap to the required depth and width. Waterproofing was required to prevent water ingress leaking into the channel from the negative side.

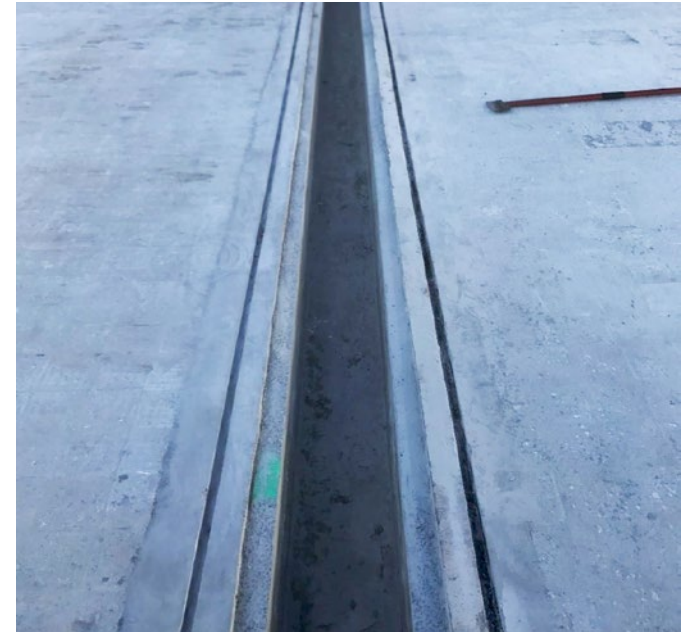
Rebuilding of channel base and walls with Epoxy resin system. Re-cut new joint detail to match original profile.

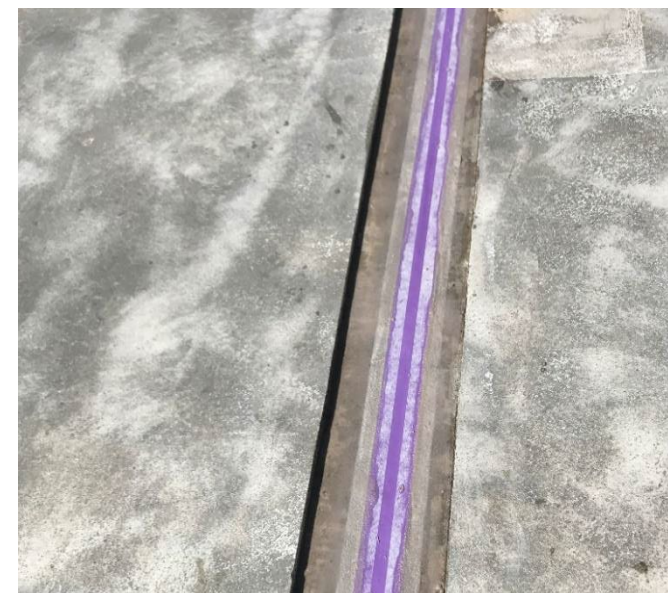
Joint band system installation to expansion joints.

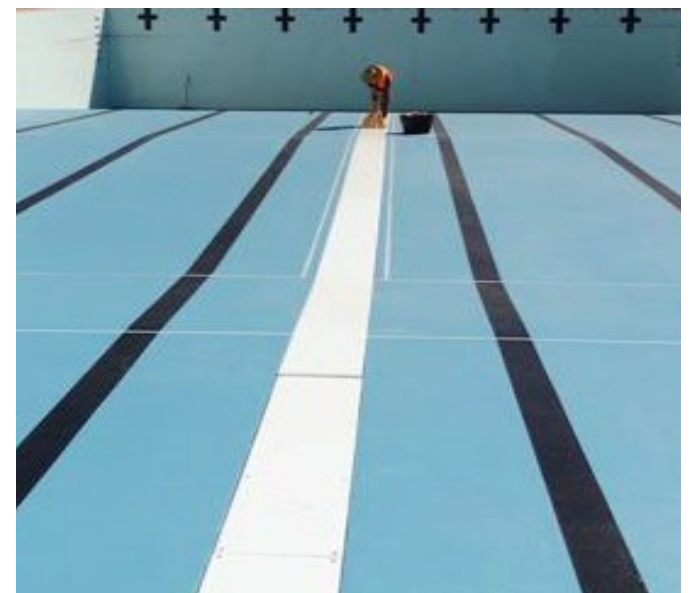
Chemical resistant sealant installed to construction joints subsequent to Epoxy pool coating installation.

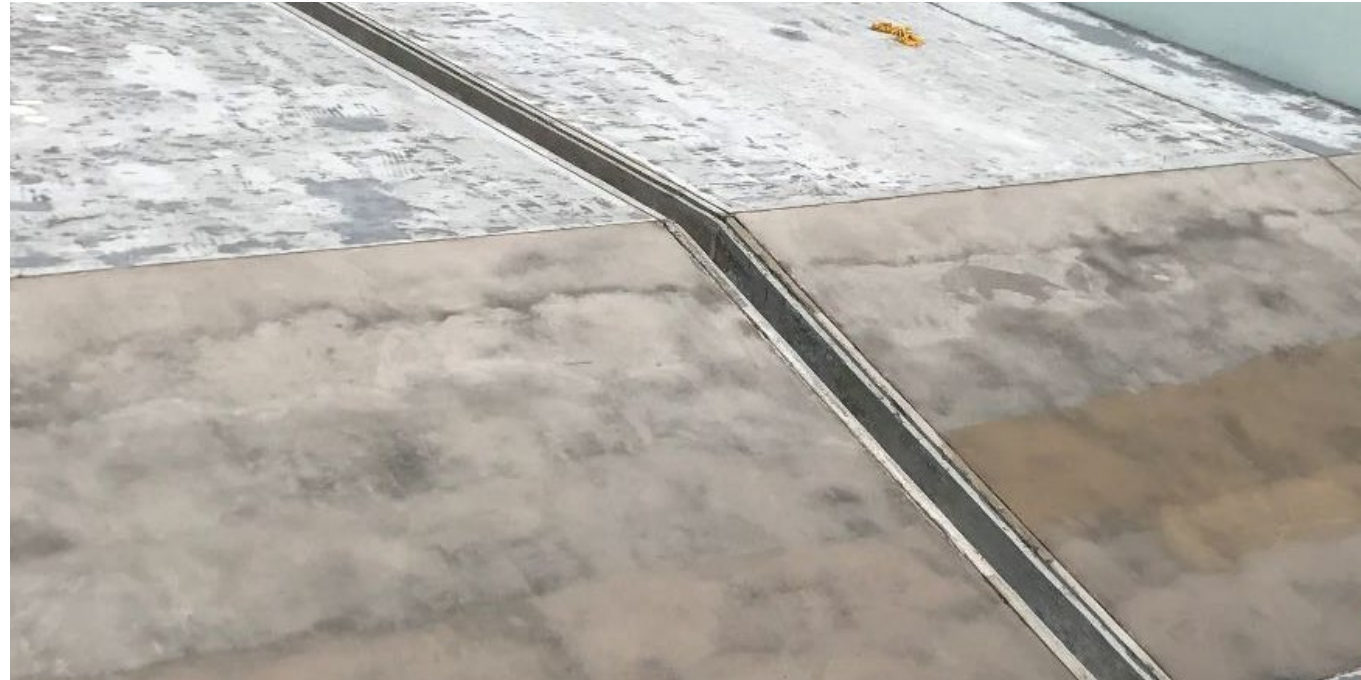
Installation of Epoxy resin system applied to the complete floor surface prior to priming.

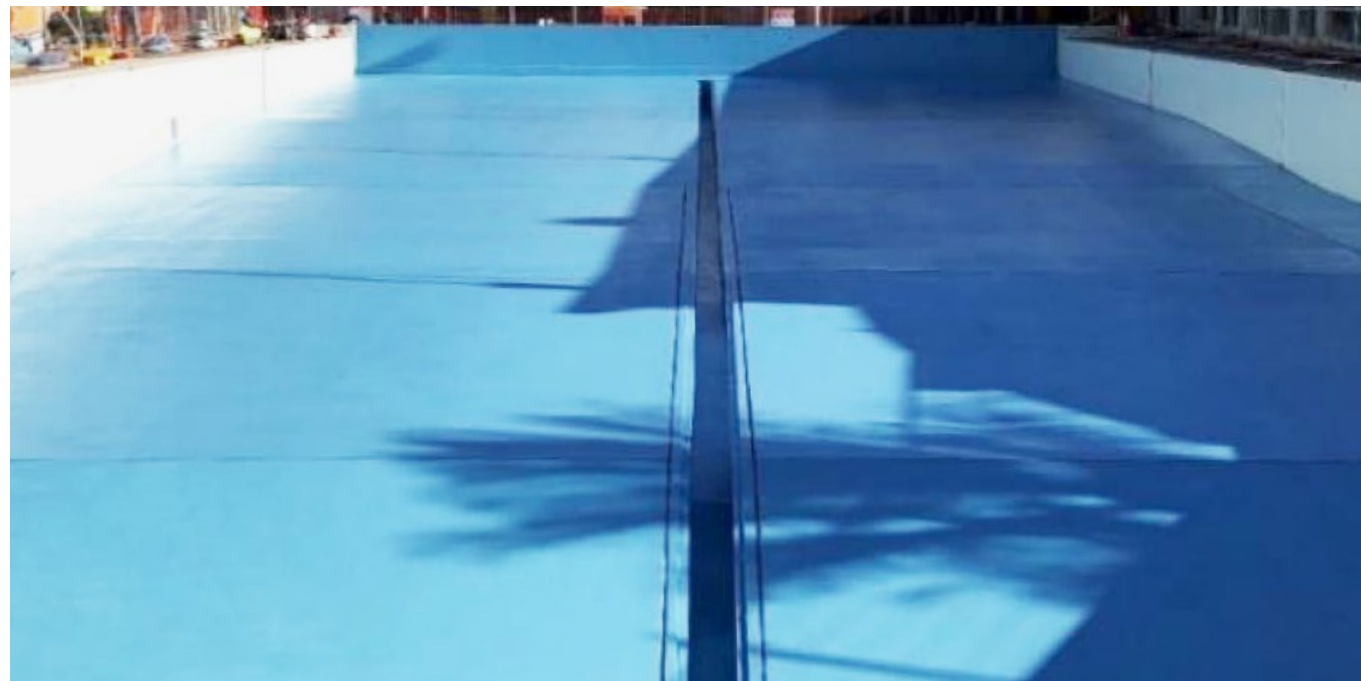
Installation of primer base coat to complete floor surface.

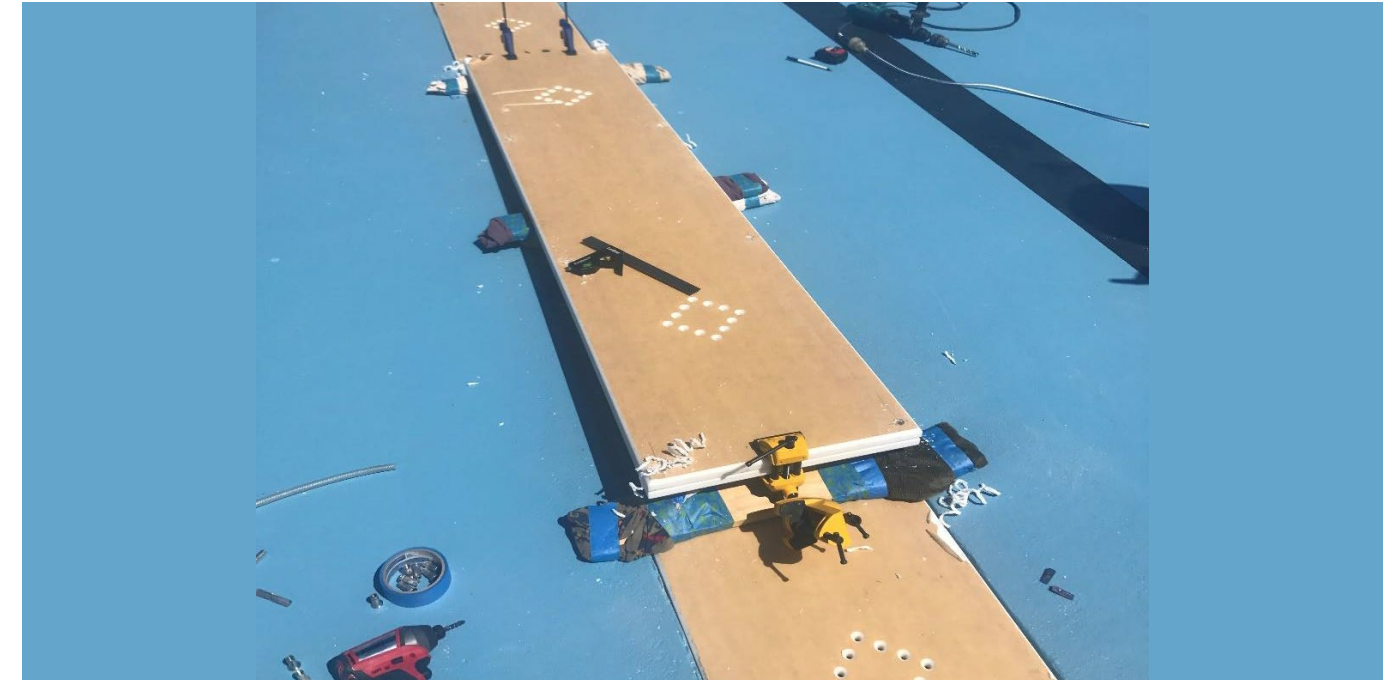
Installing and set up new centre feed line cover plates.

- Re-design centre feed line cover plate to avoid re-earthing, hence eliminating earth bonding requirement.
- Expansion joints required a complete bandage detail to provide optimum protection.

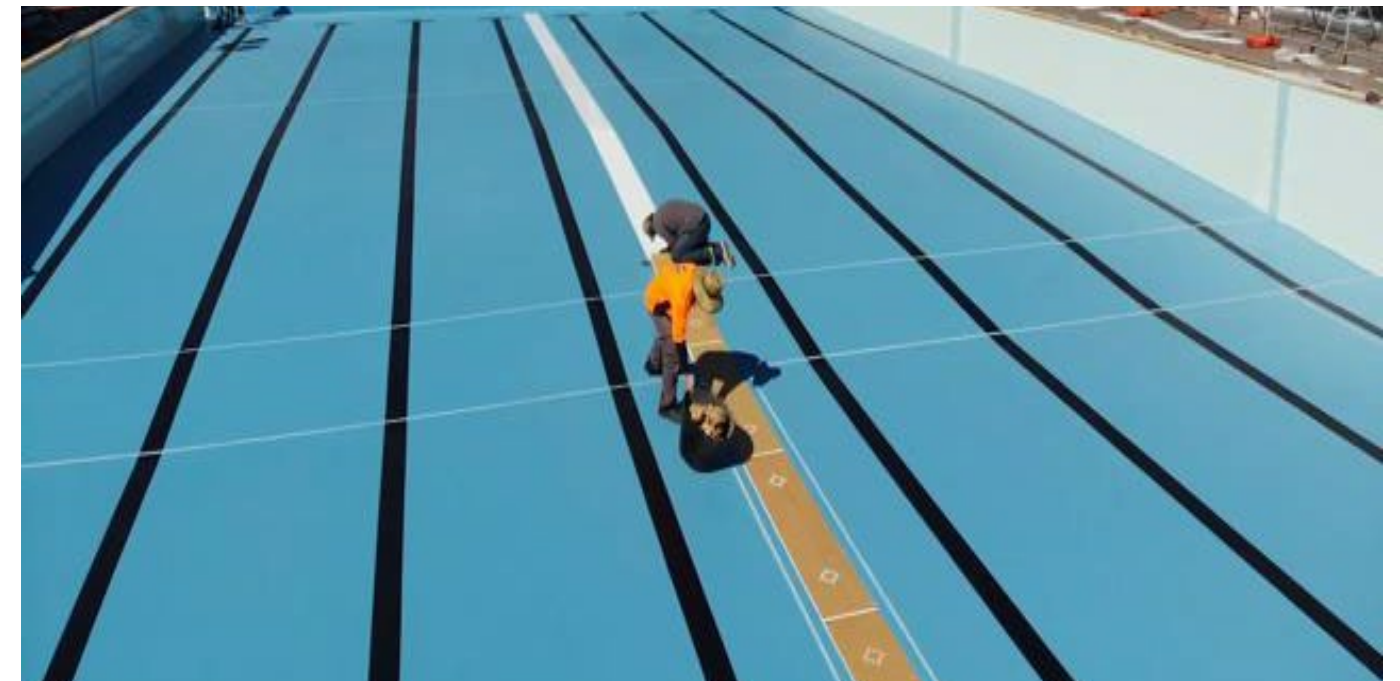
Completed installation of new cover plates.
