Olims Hotel Brisbane

Swimming Pool Major Renovation

Swimming Pool Major Renovation and Complete Remediation

Site: Olims Hotel Brisbane CTS 3563

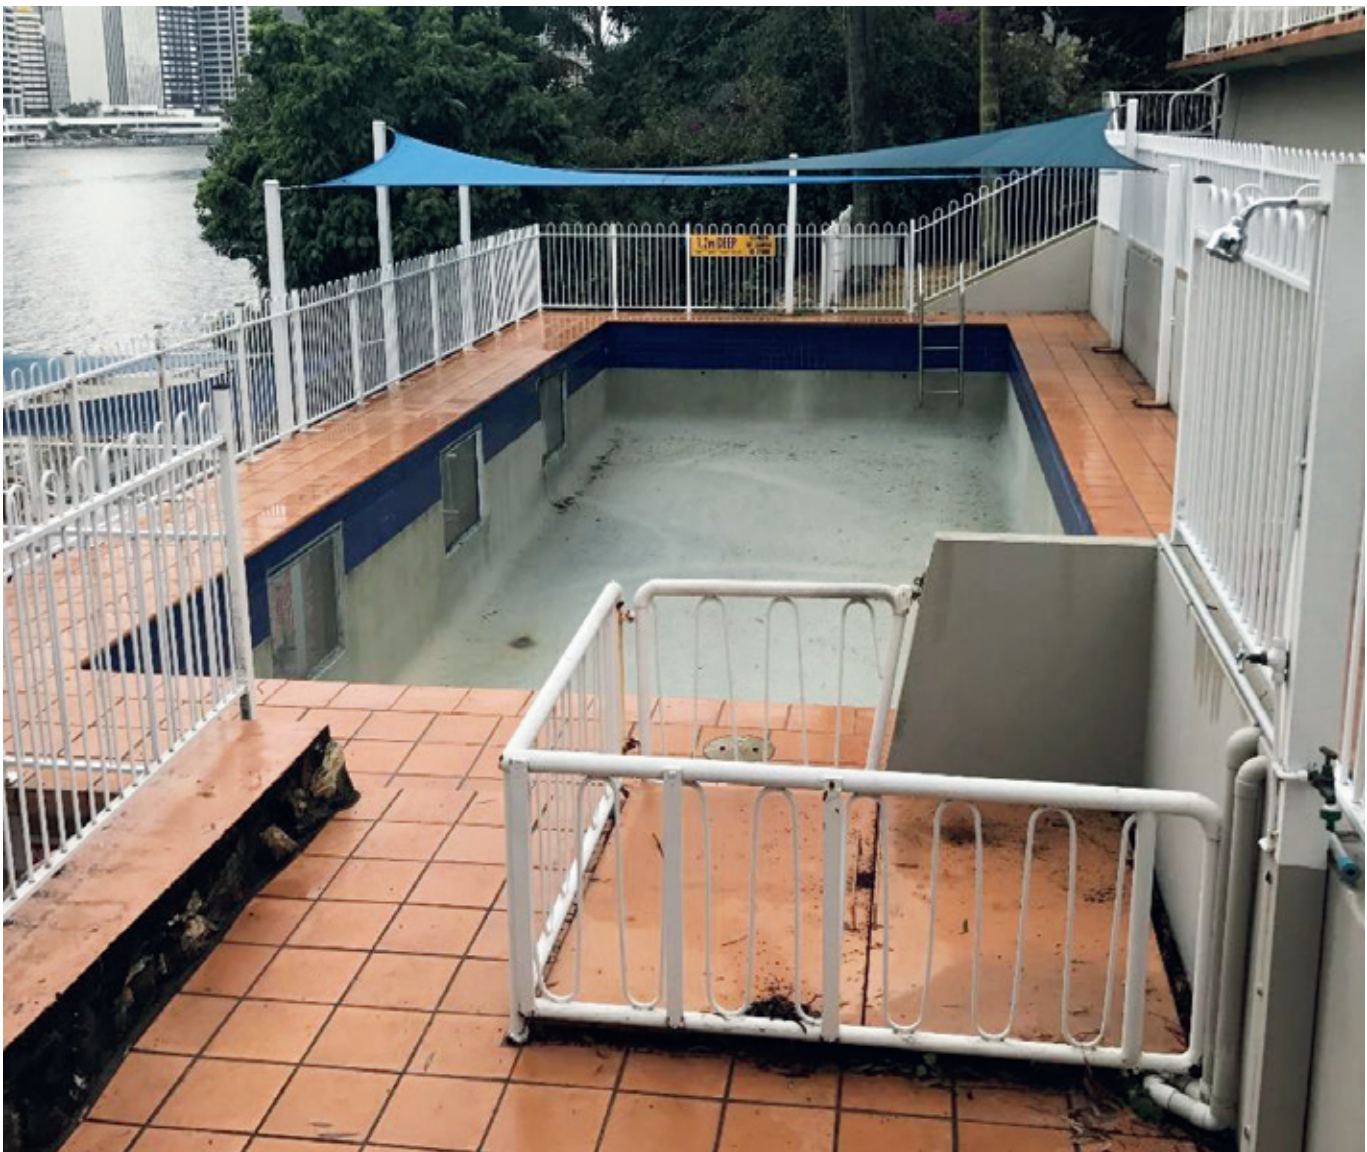
The pictures included show the existing condition prior to the commencement of the job.

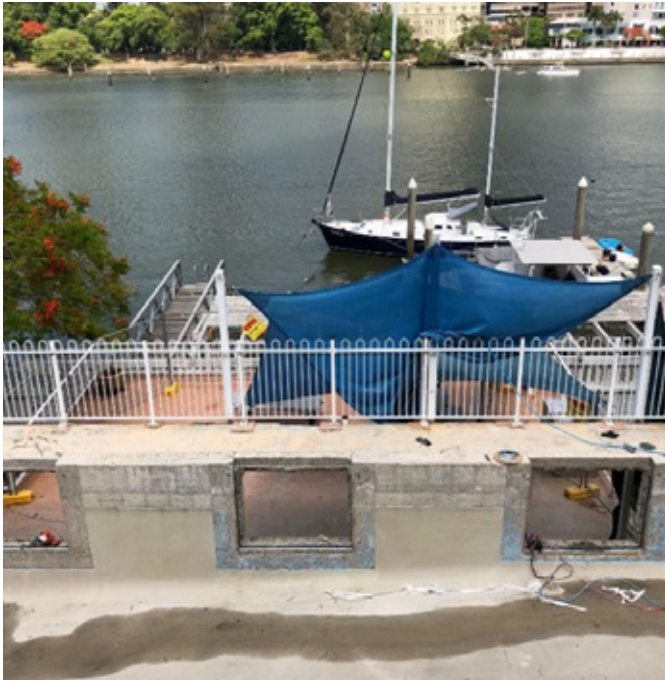
Excavating window voids

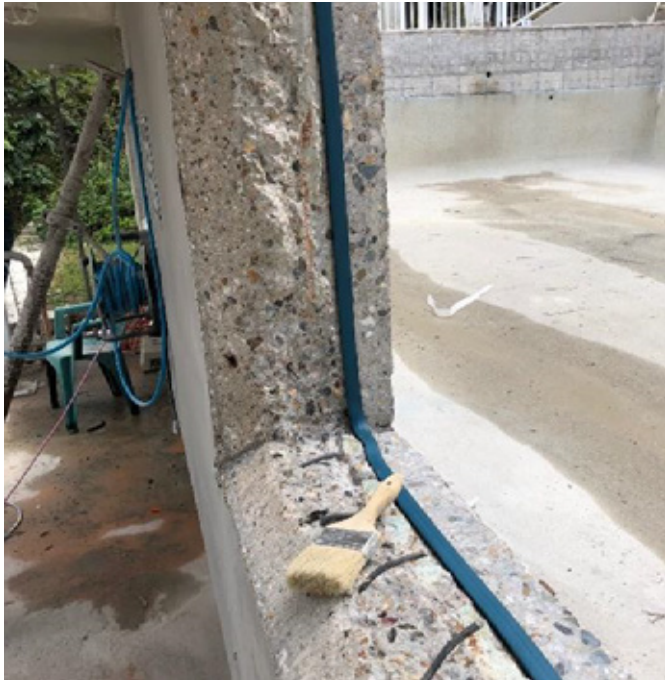
Install waterstop

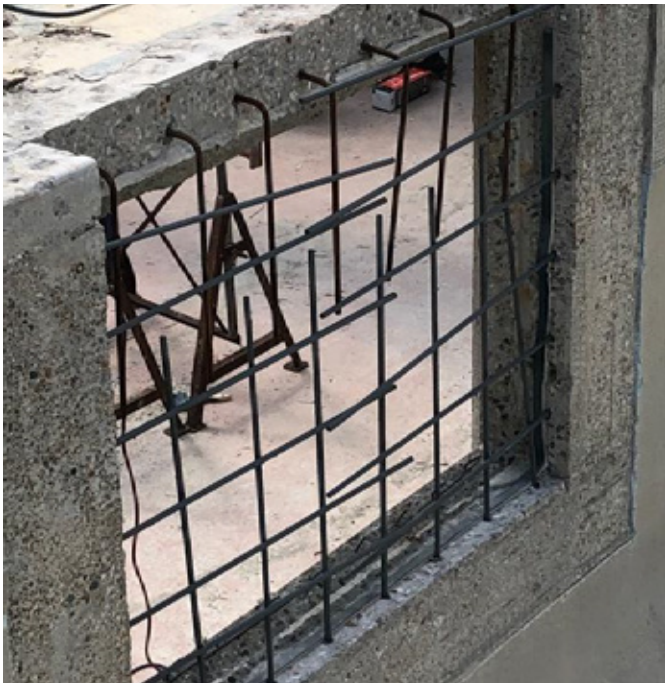
Install steel reinforcing

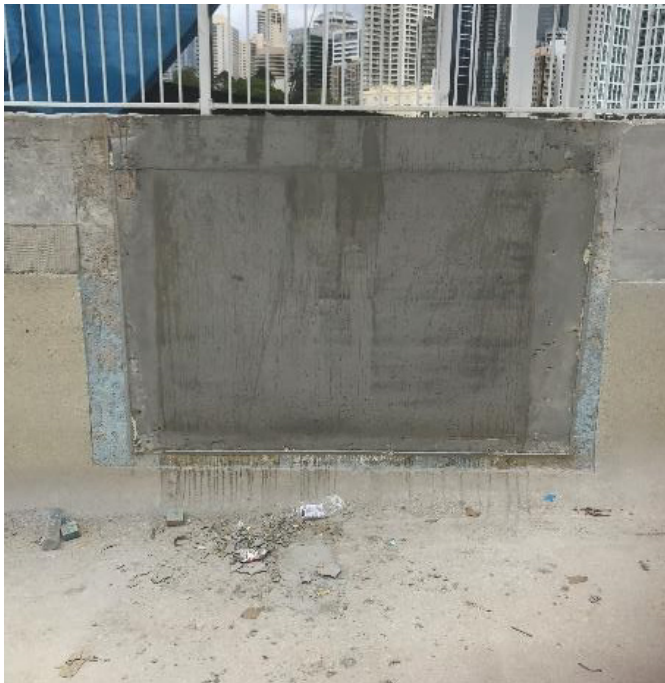
Pour construction grout

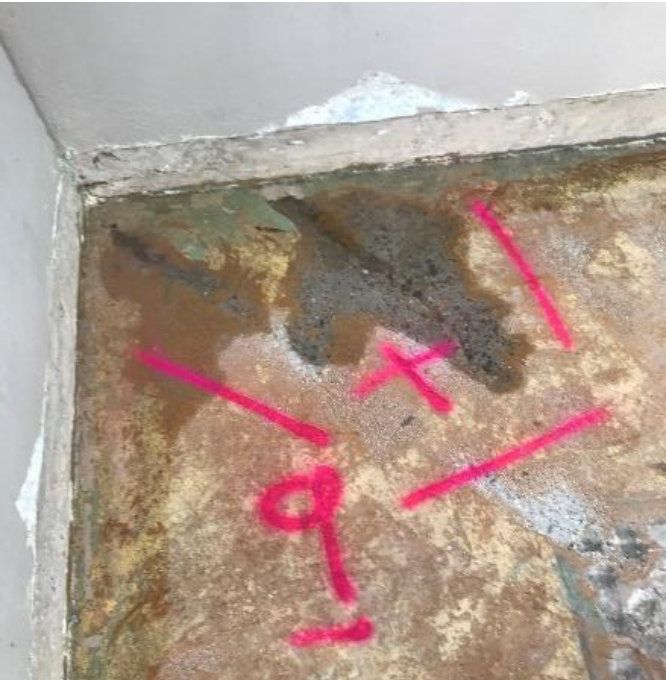
Identify repair area and mark out

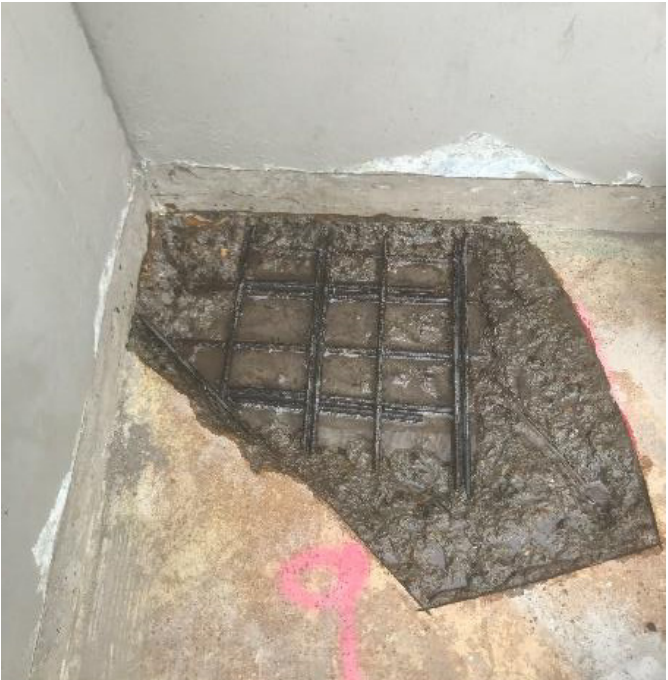
Excavate loose concrete and prepare steel

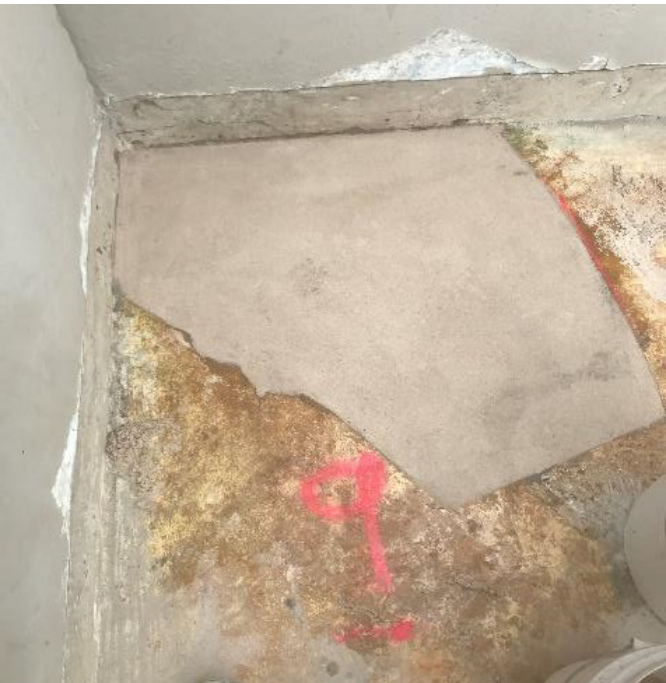
Install epoxy resin system

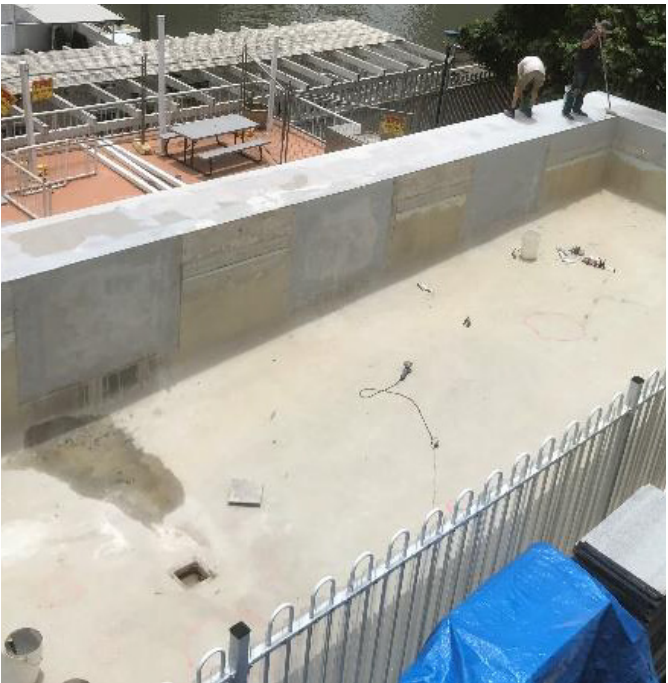
Waterproofing prepared concourse

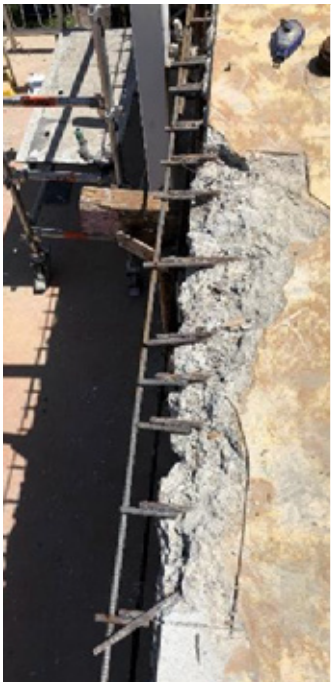
Excavate loose and flaky concrete

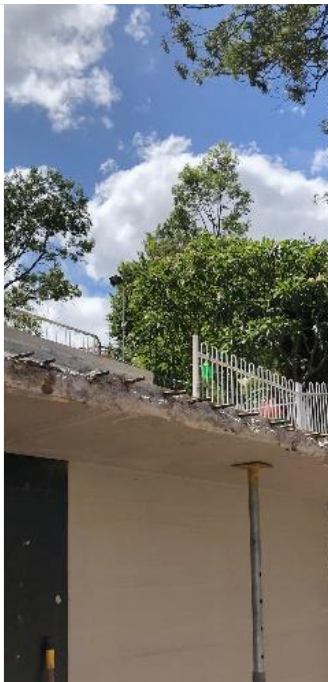
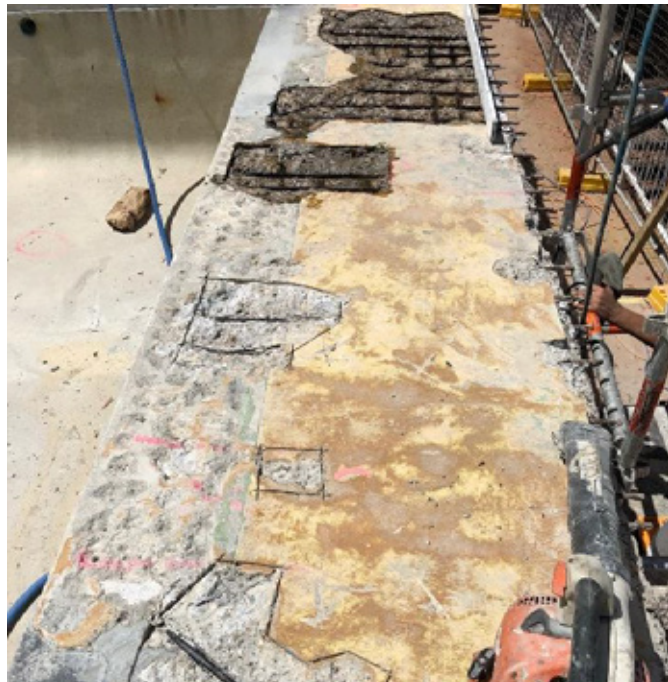
Clean and treat steel. Install new steel as required

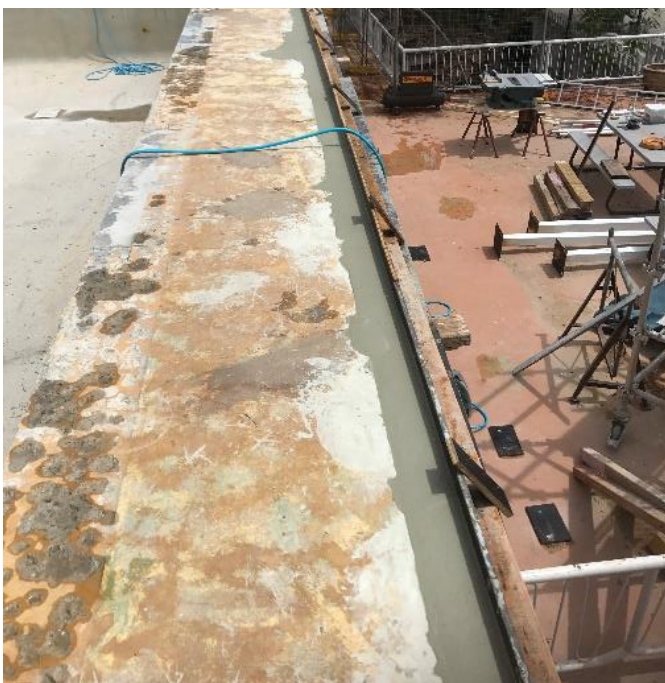
Formed up and poured using engineered mortar

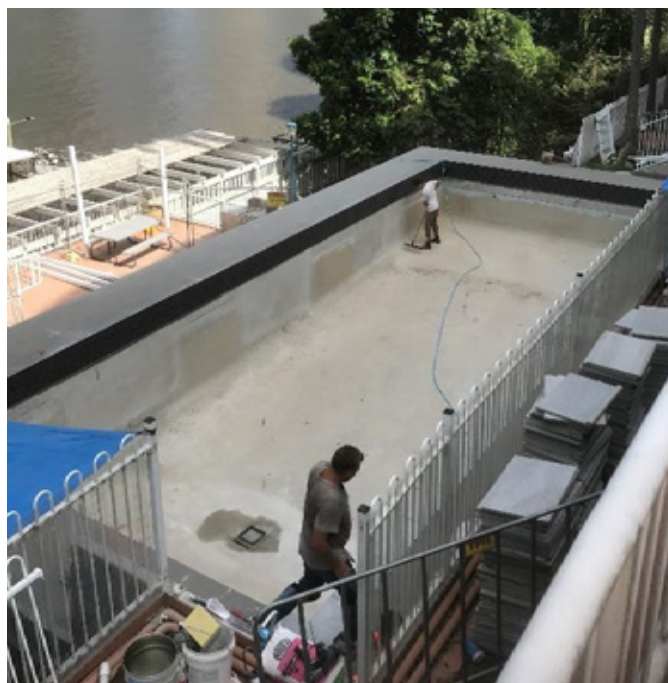
Fully waterproofed concourse and overhang slab

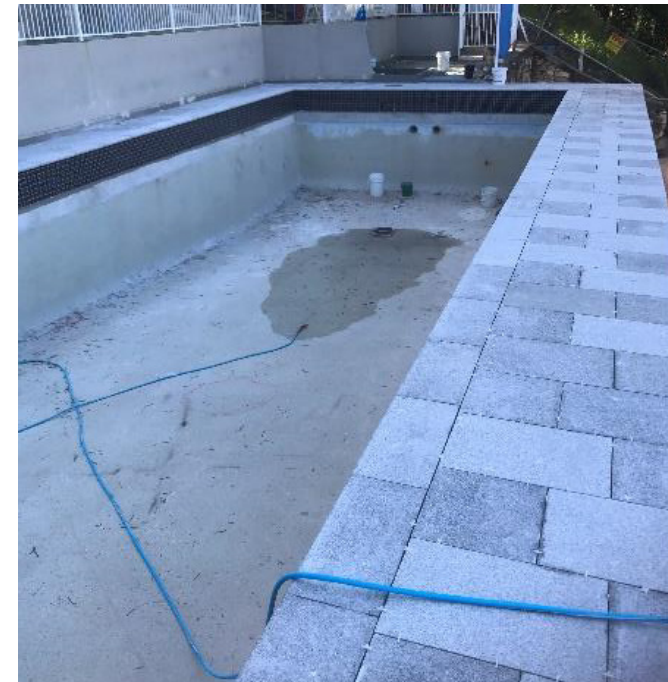
Granite tile installation

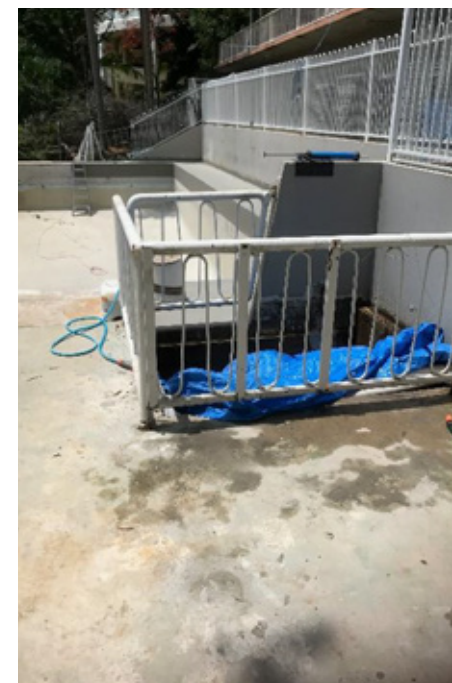
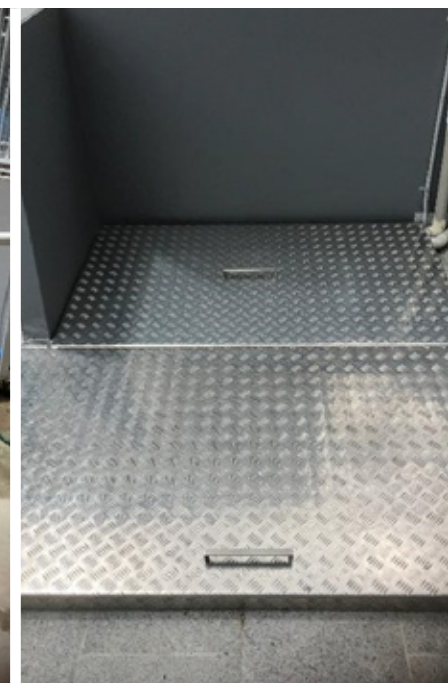
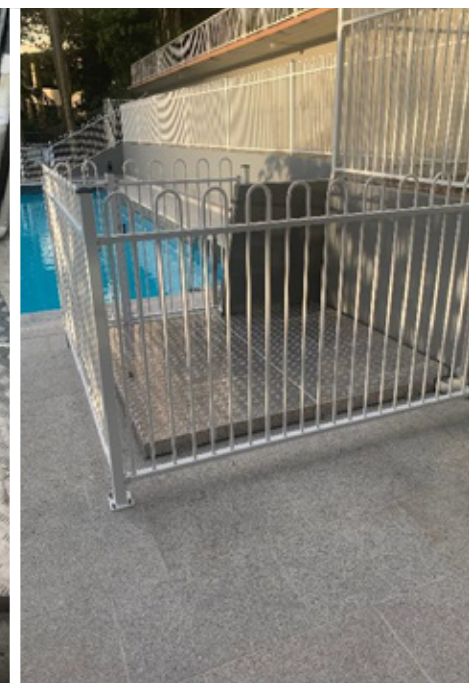
Pool Pump Pit Lid Refurbishment with new Aluminum Checker Plate Lid and matching fence
