## Kerb Remediation and Traffic Island Crack Repair

Client: Goodstart Early Learning Boronia Heights

Scope: Kerb Remediation Traffic Island  
Crack Repair

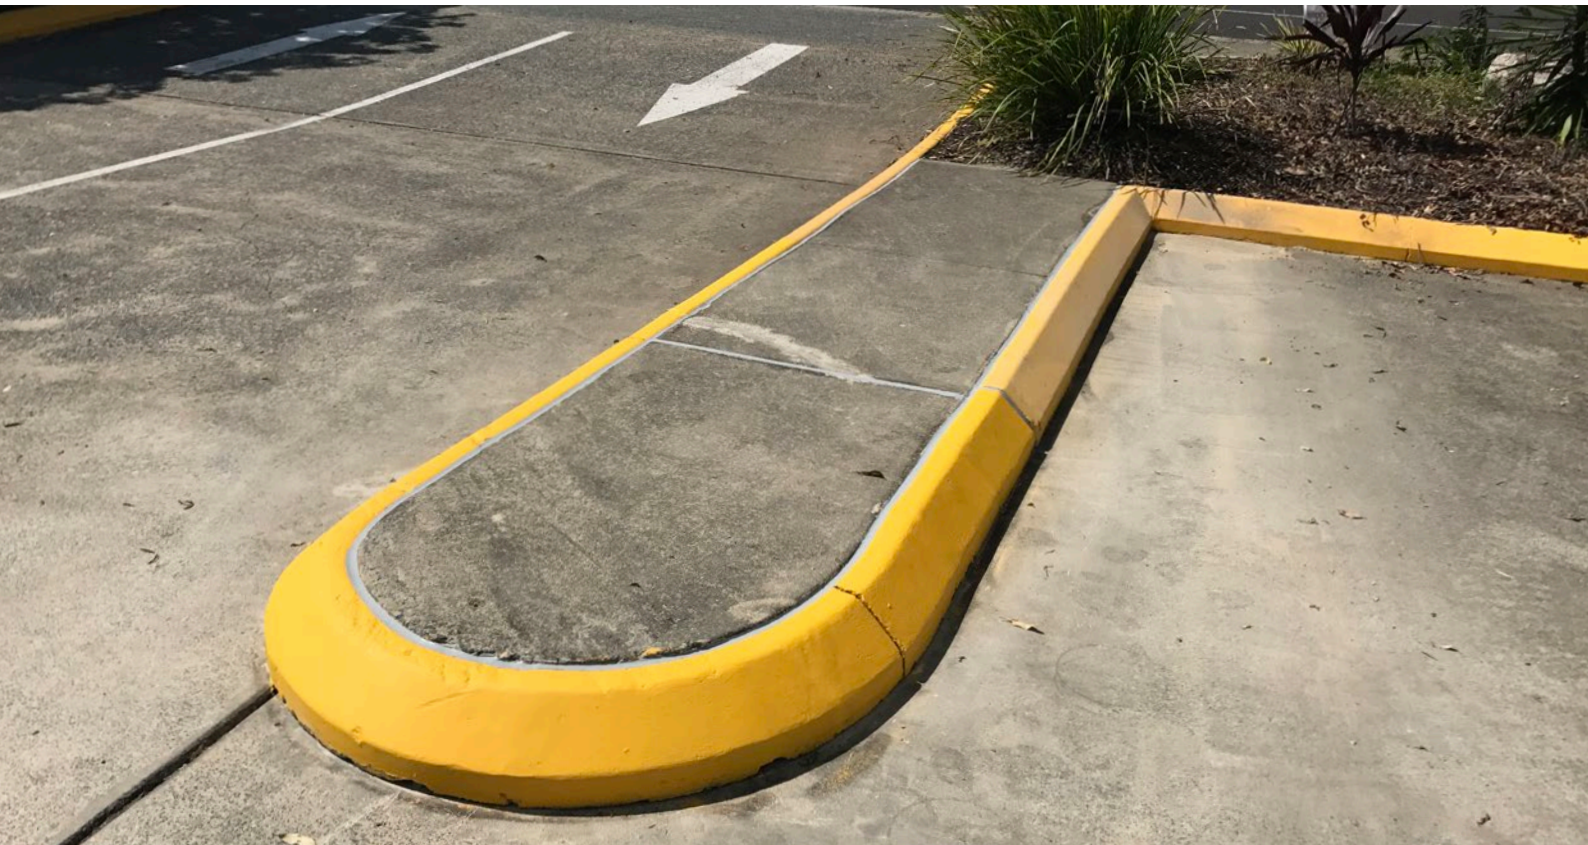
The outcome sought by the Client was to remediate the cracked concrete and reinstate the kerb following damage caused by a delivery truck.

- Clean and prepare the concrete crack and cracked kerbing pieces by mechanical grinding
- Reposition the broken pieces to original position
- Install 16mm booker rod pins to secure the kerbing to the base slab
- Apply gap filling epoxy construction adhesive to the kerb/island interface and pin installation penetrations
- Apply sealant to any visible cracks
- Repaint kerbing to match
- Comply with site specific safety requirements
