Complete Remediation – Toddler Pool

Client: Toowoomba Regional Council
Scope: Complete Remediation

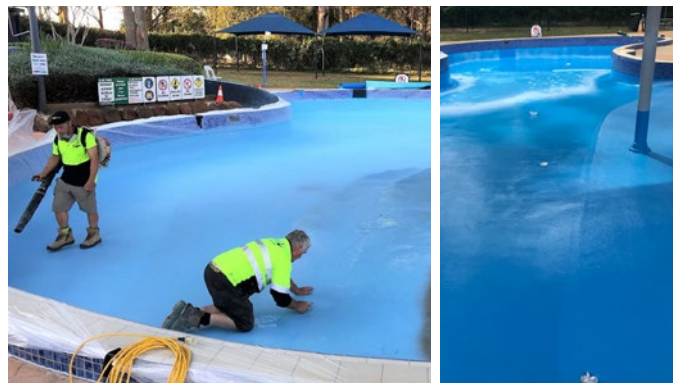
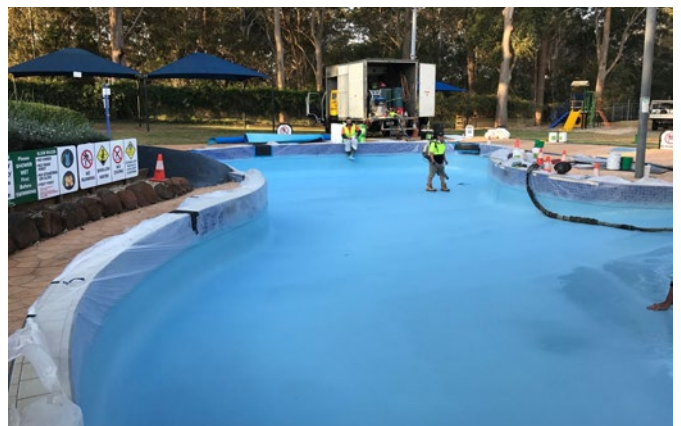
During

- Remove existing chlorinated rubber lining
- High pressure water blast and diamond grind substrate
- Clean and reprofile construction joints
- Install Epoxy coating with anti-slip on entry ramp
